Report No. FAA-SS-72-05

**SST Technology
Follow-On Program — Phase I
TITANIUM ALLOYS 6AI-4V
AND
3AI-2.5V HYDRAULIC TUBING**

**D6-60205
July, 1972**

**FINAL REPORT
Task 1**

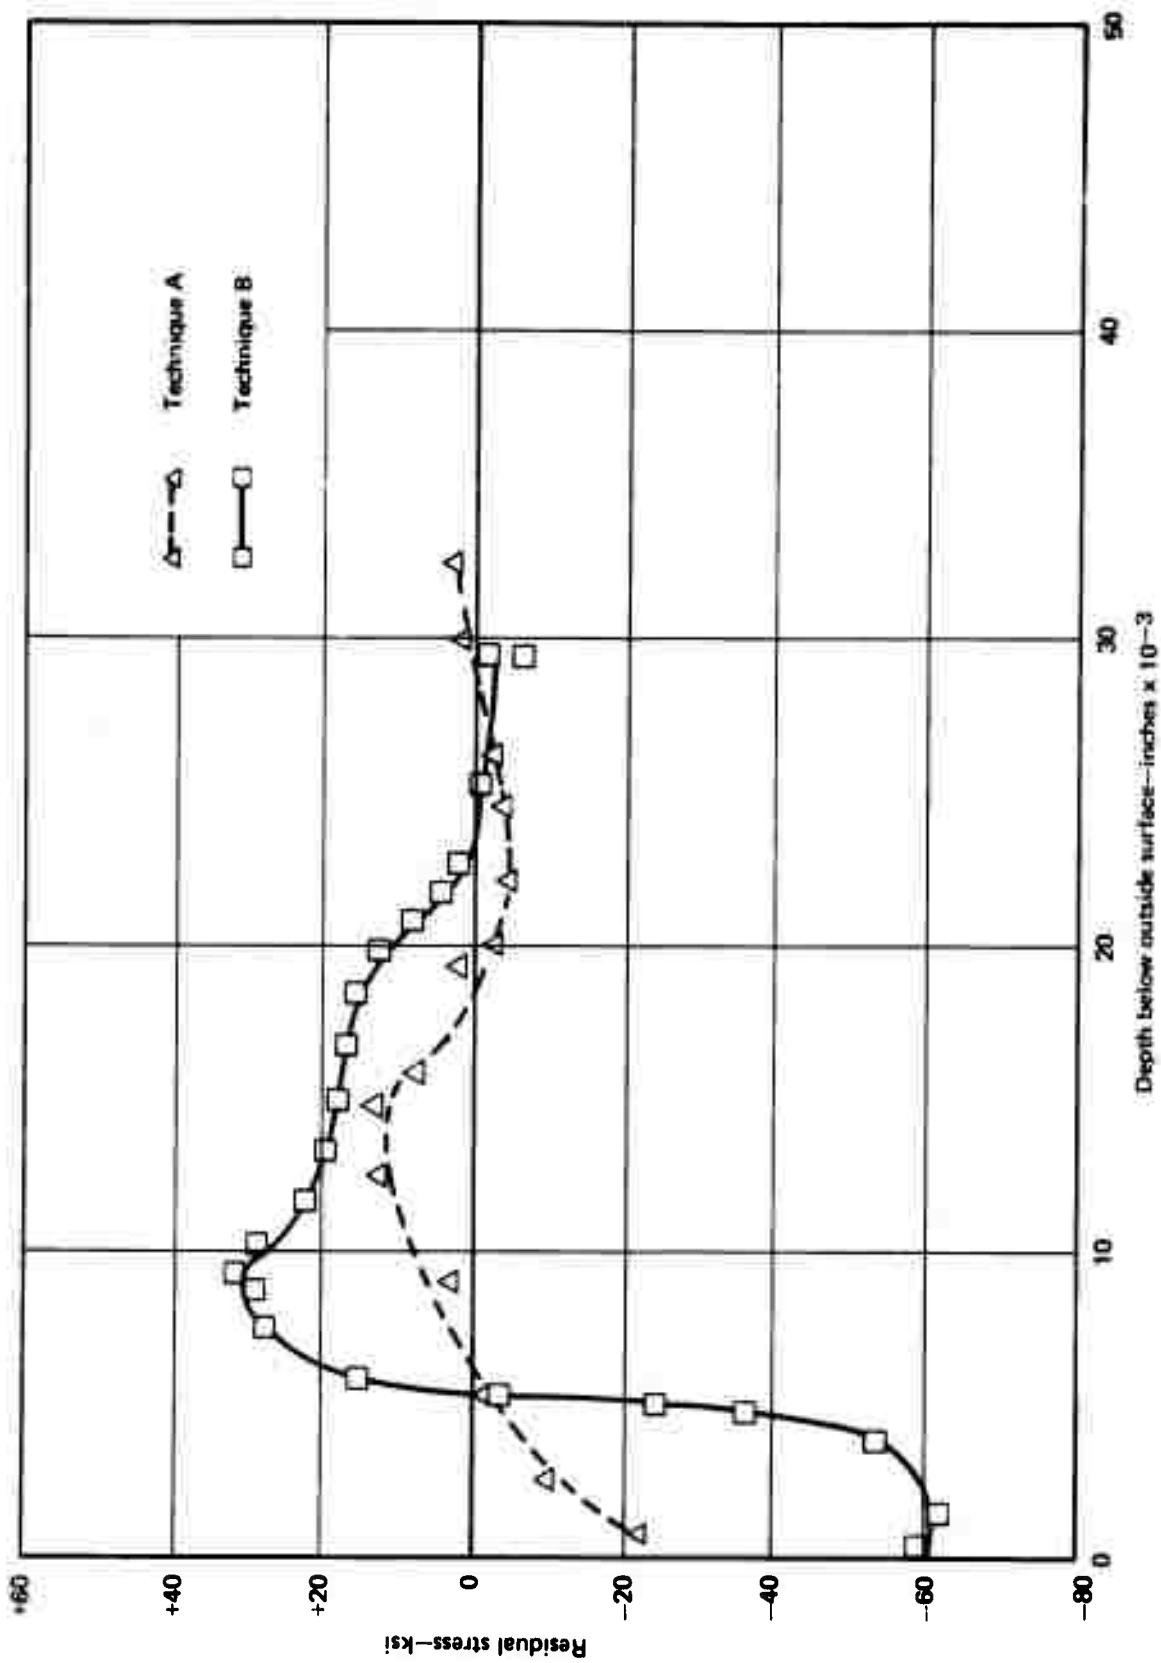
FIGURE 36.—RESIDUAL HOOP STRESS IN TUBE C (5/8 IN. X .033 IN.)

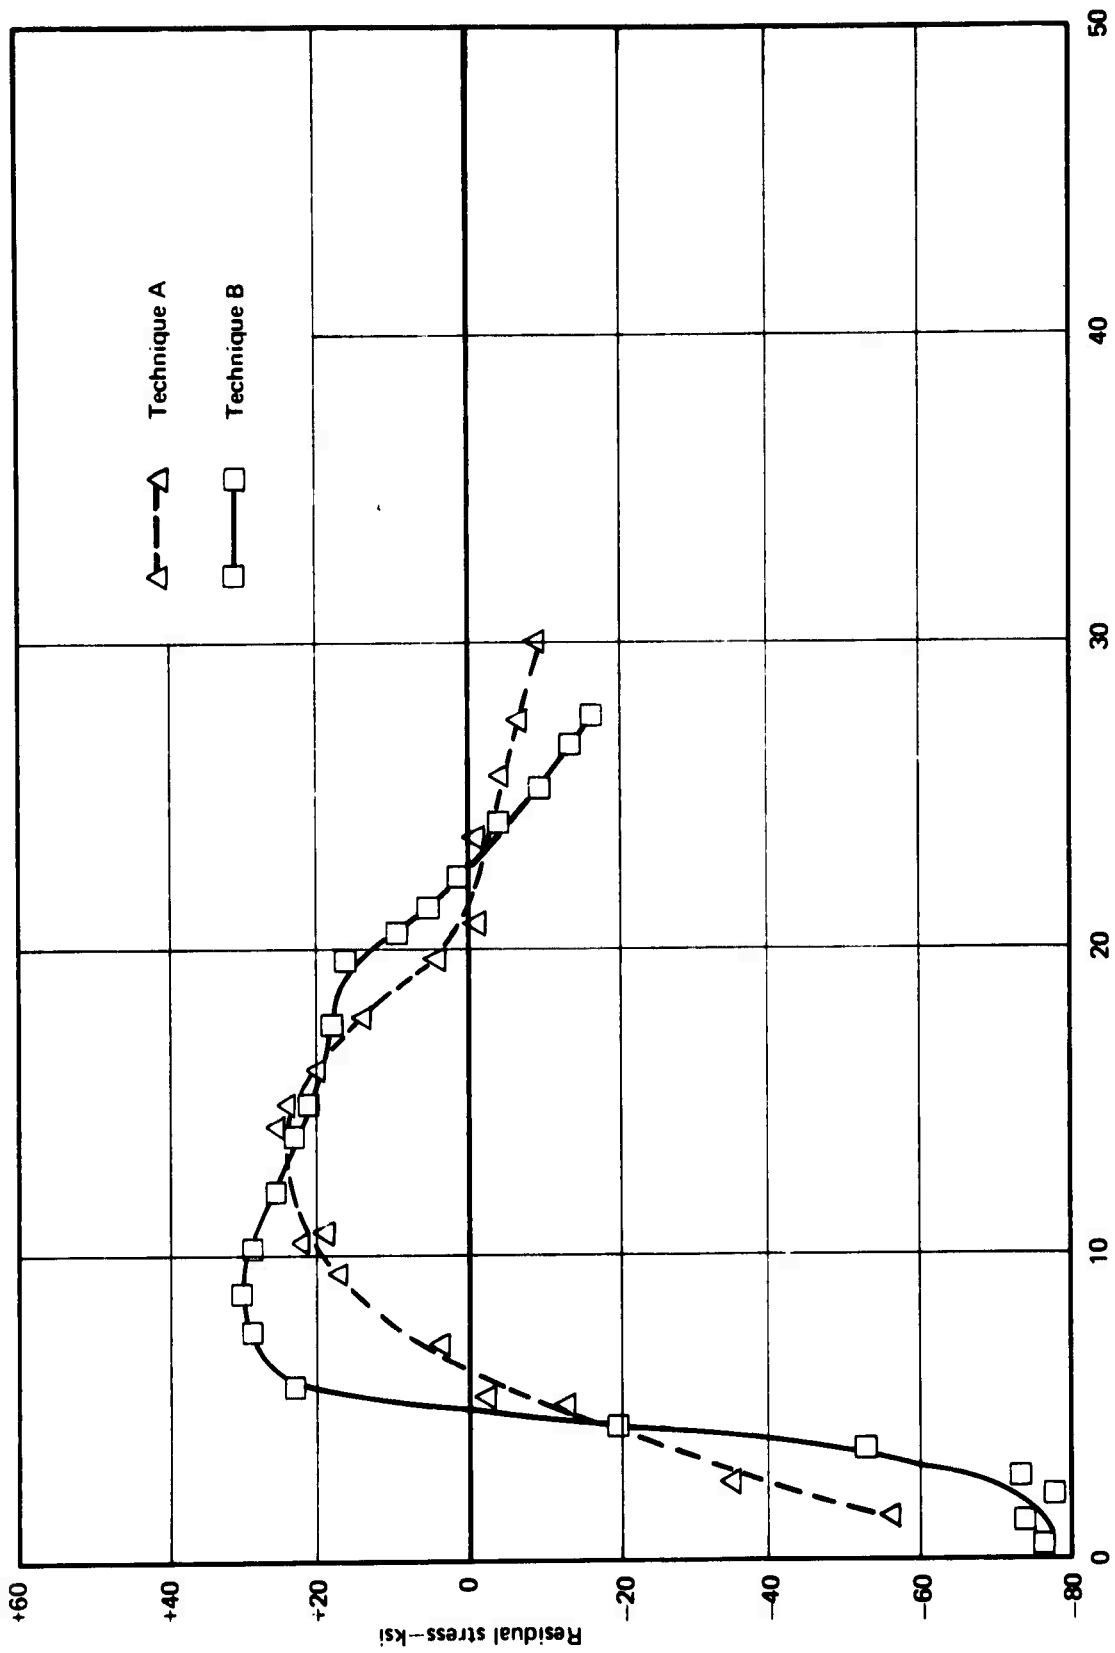
FIGURE 37.—RESIDUAL HOOP STRESS IN TUBE D (1½ IN. X .026 IN.)

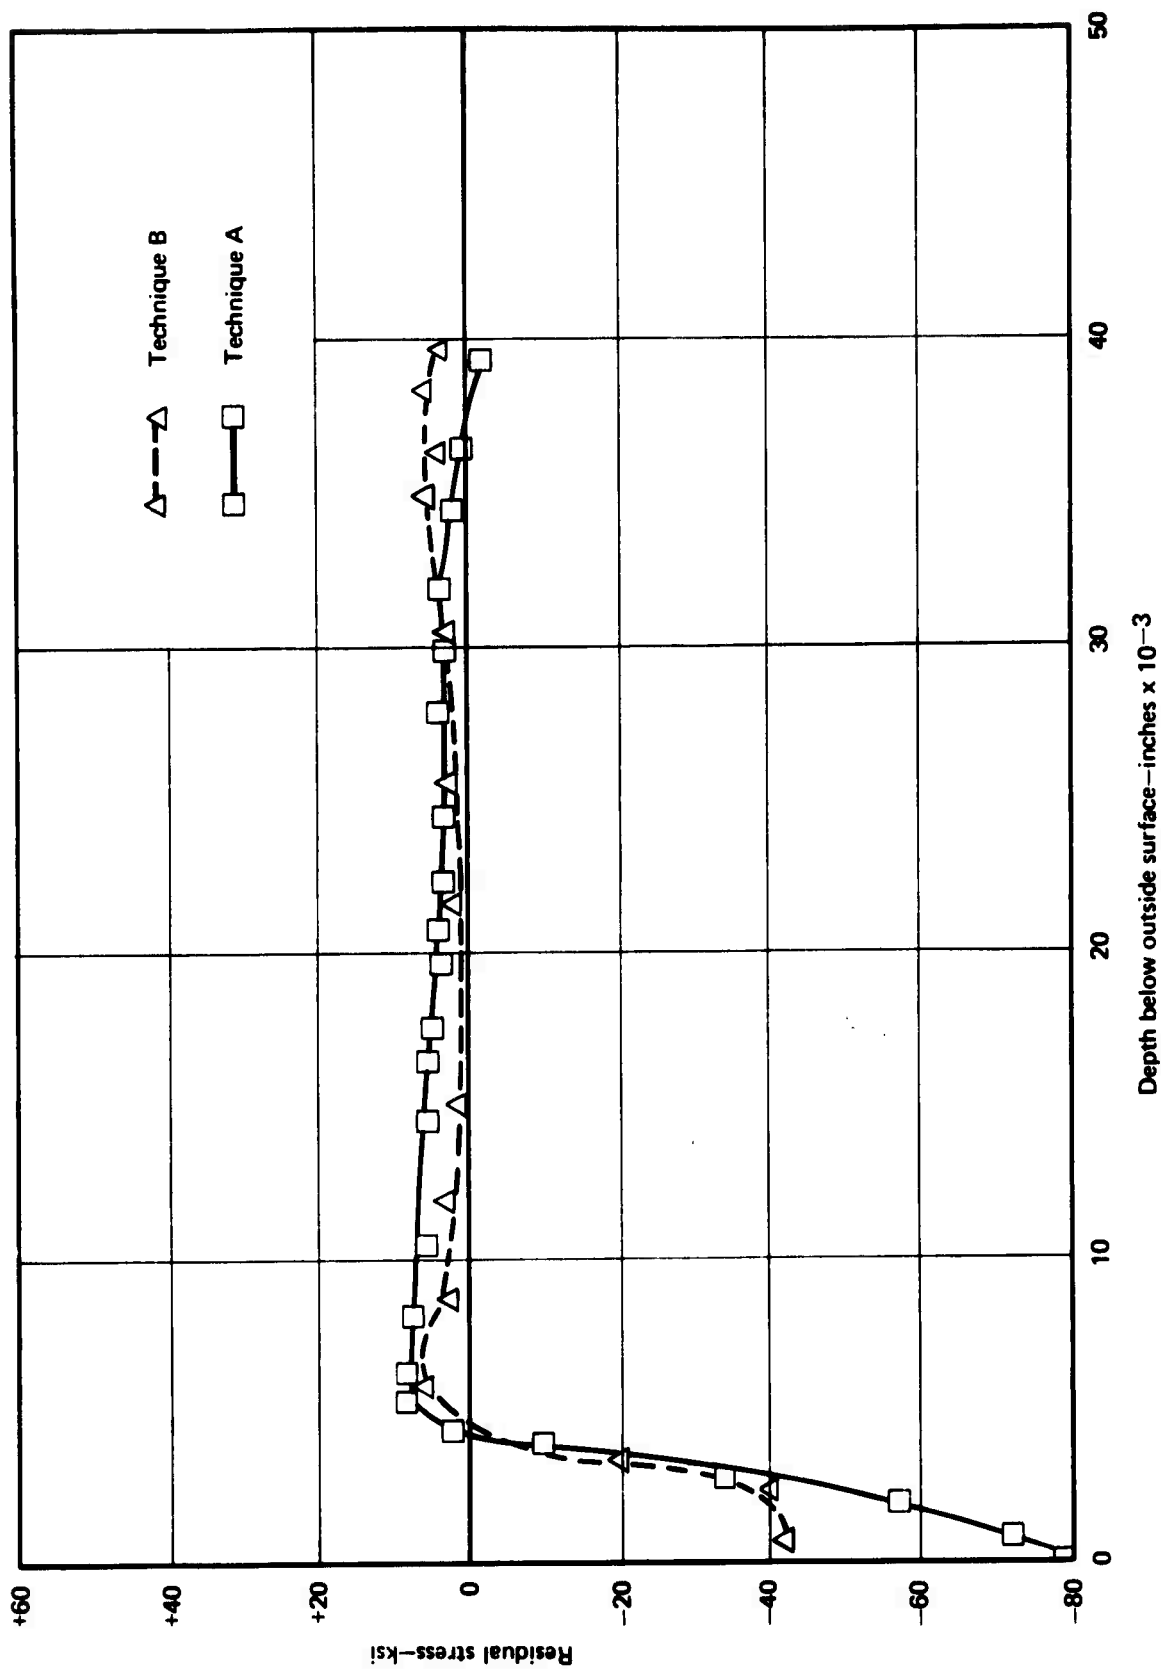
FIGURE 38.—RESIDUAL HOOP STRESS IN TUBE E (3/8 IN. X .020 IN.)

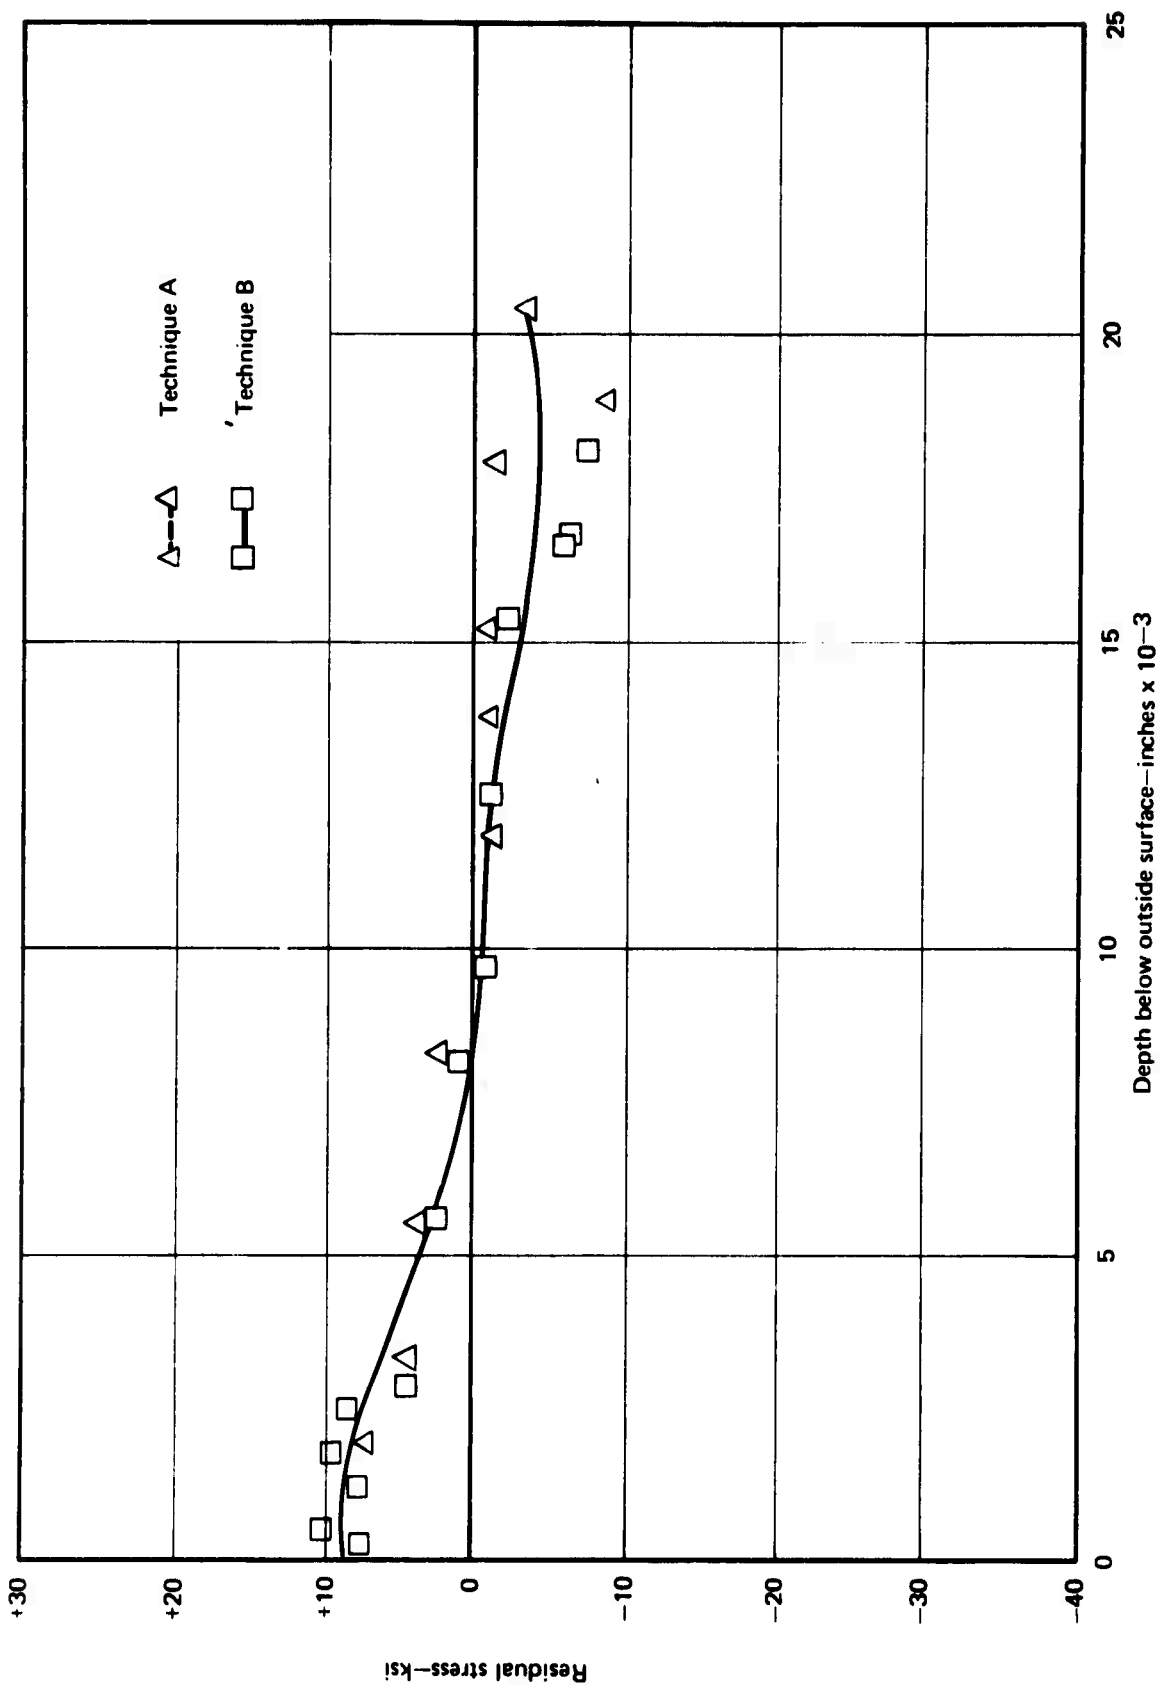
FIGURE 39.—RESIDUAL HOOP STRESS IN TUBE F (3/8 IN. X .020 IN.) UNPEENED

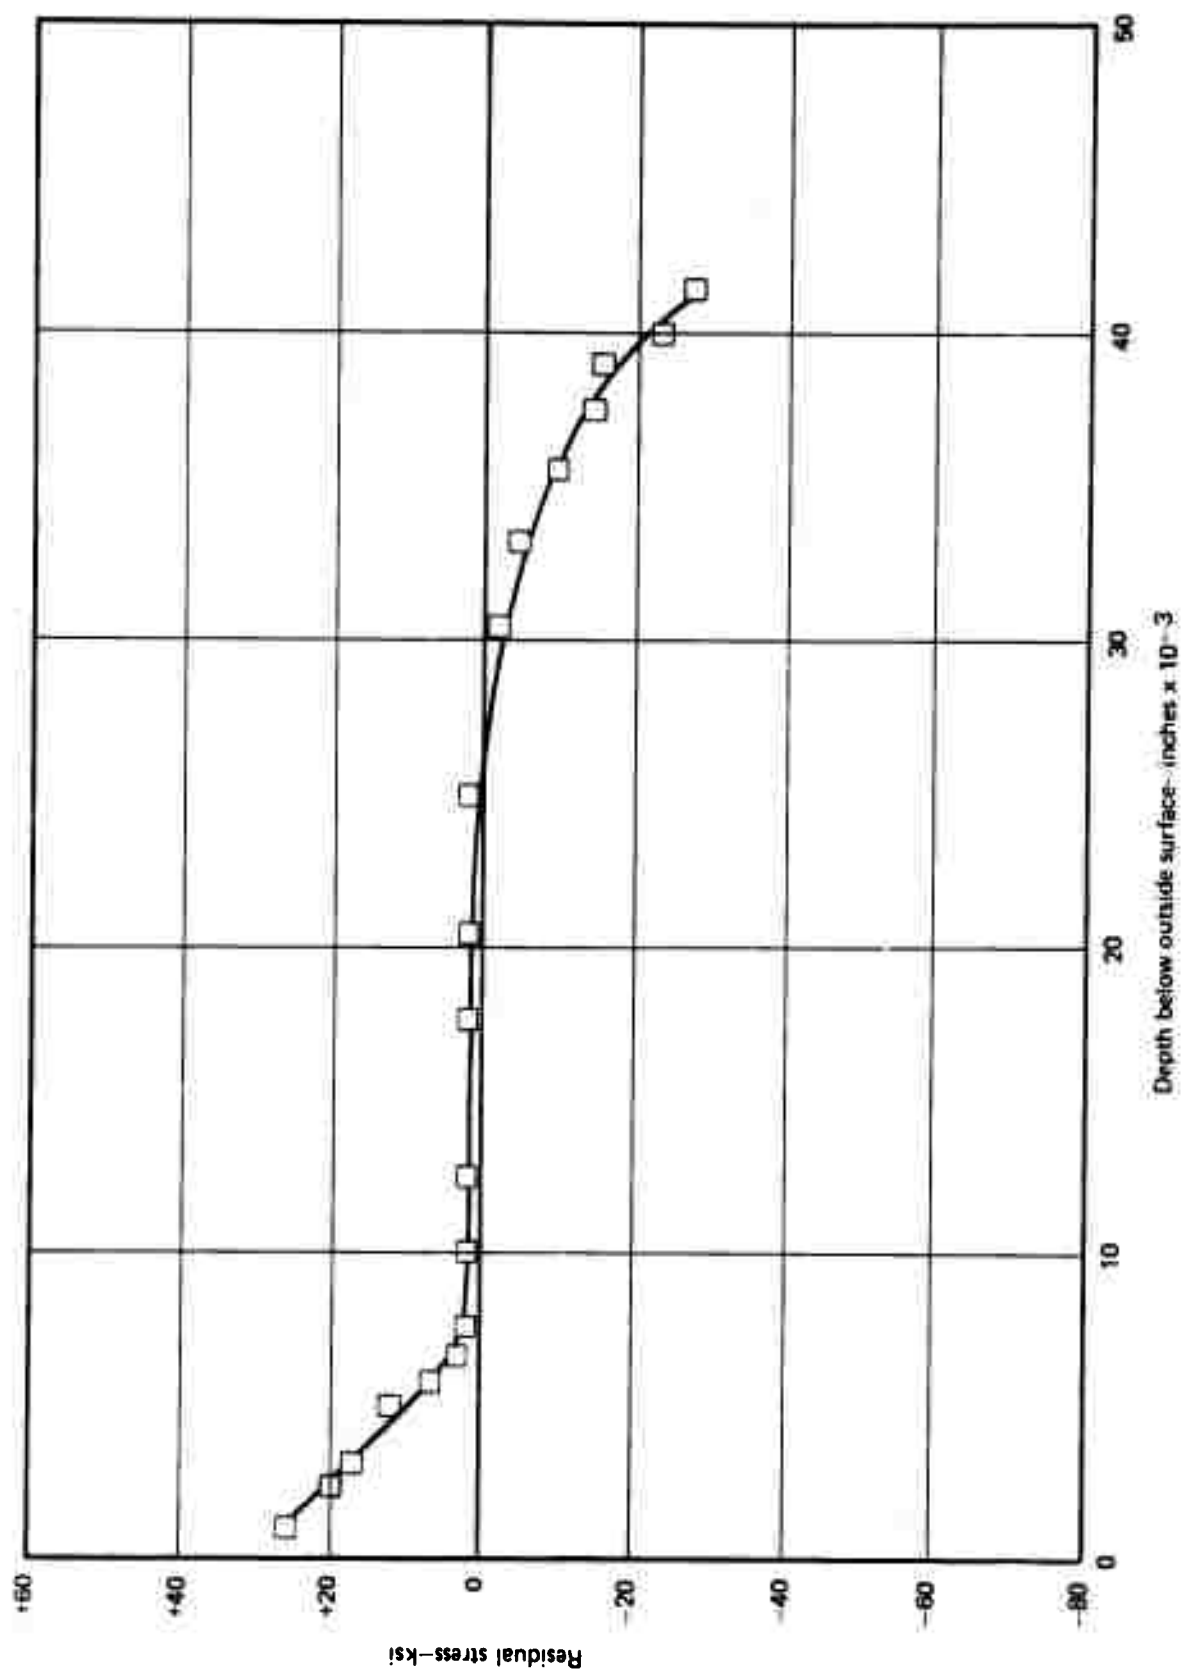
FIGURE 40.—RESIDUAL HOOP STRESS IN TUBE G-C (1/4 IN. X .045 IN.) AS RECEIVED FROM THE VENDOR

Another tube (G) was cut into four equal lengths. One length was retained for control data while the remaining three were peened at three shot-peen intensities: .005A2, .008A2 (specification value) and .012A2. The tubes were then examined for residual hoop stress using two methods.

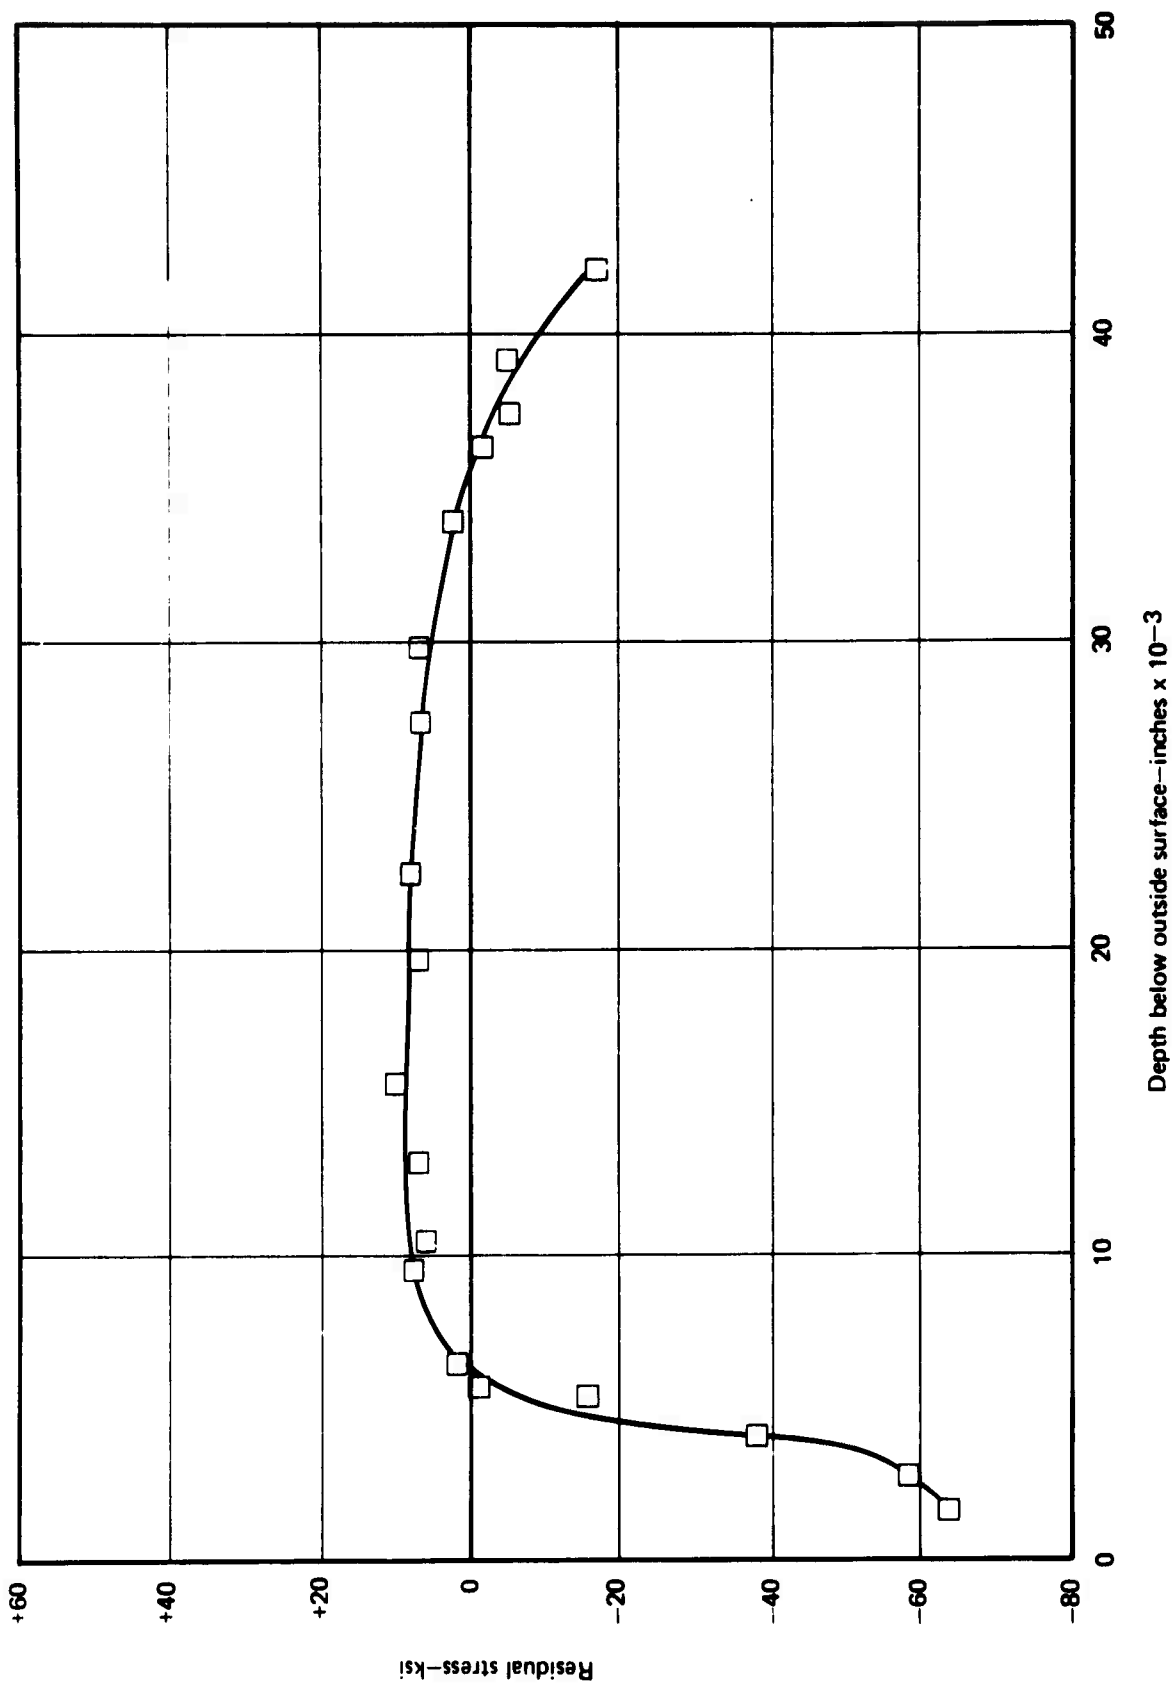
FIGURE 41.—RESIDUAL HOOP STRESS IN TUBE G-1 ($\frac{3}{4}$ IN. X .045 IN.) PEENED TO 0.005A2

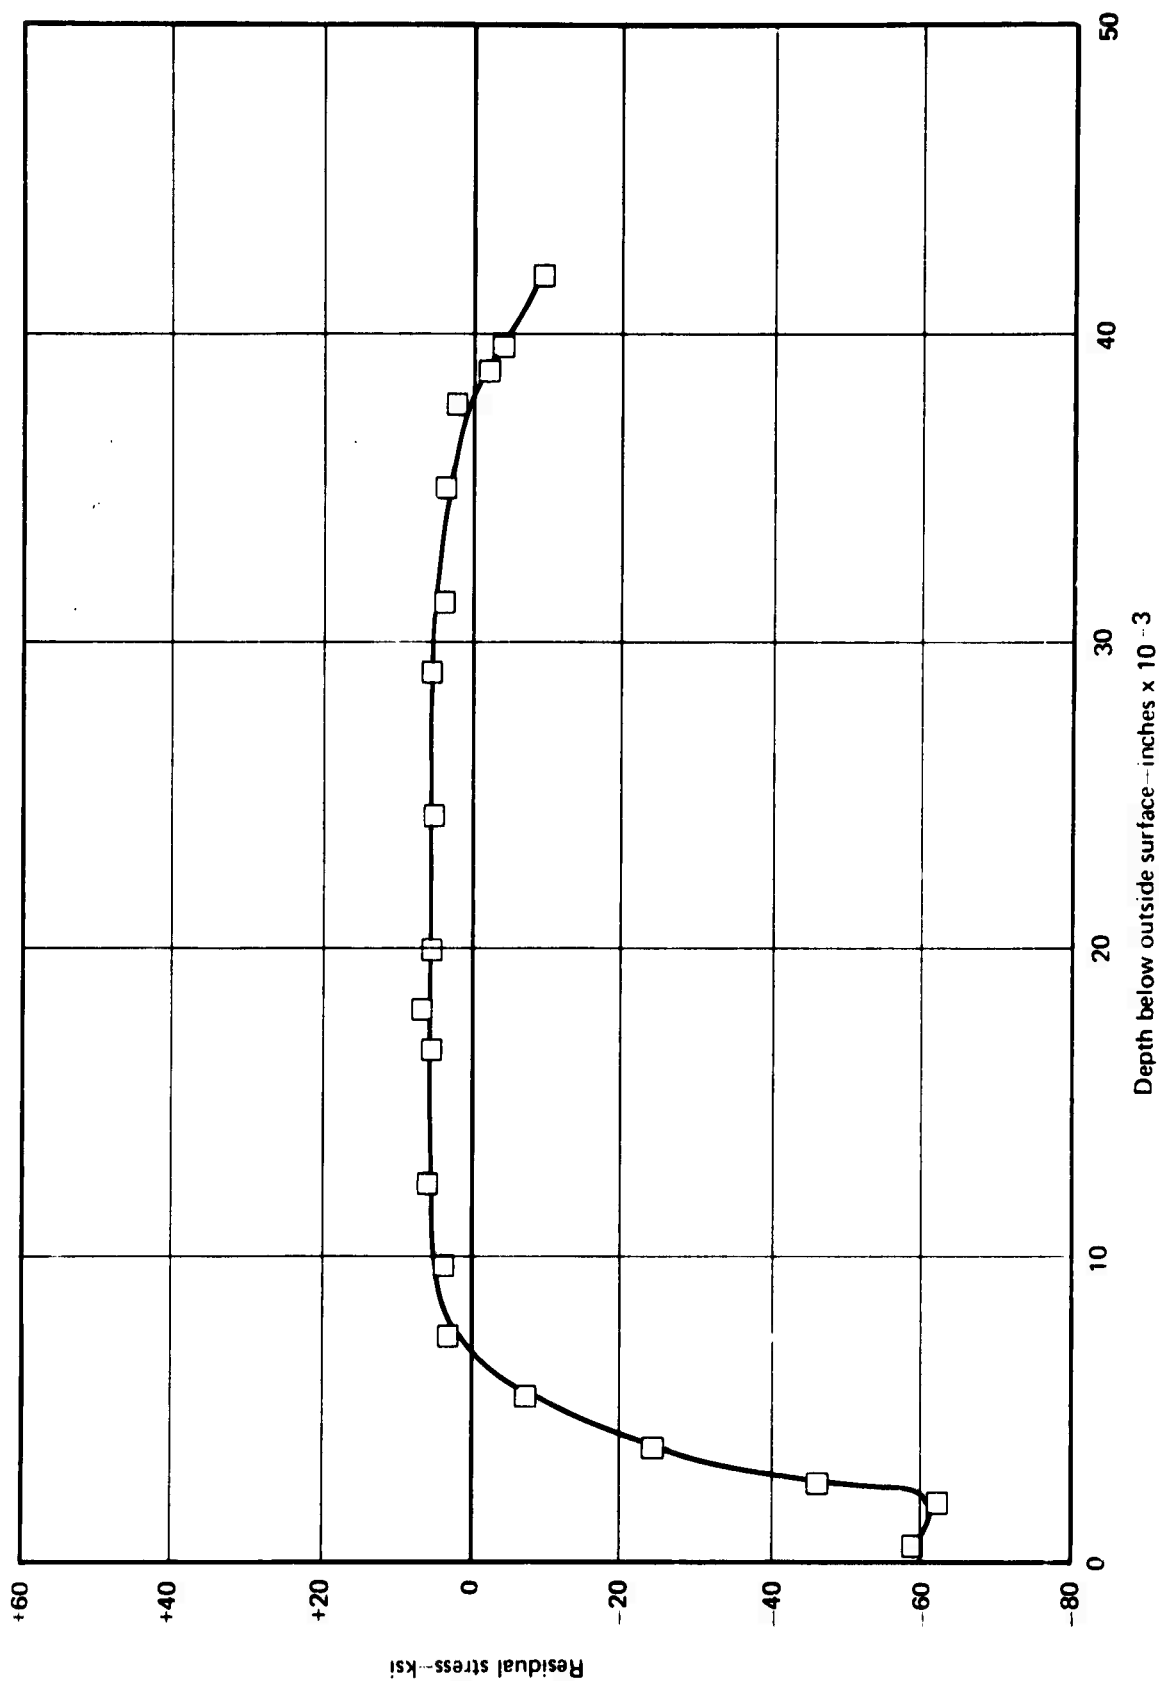
FIGURE 42.—RESIDUAL HOOP STRESS IN TUBE G-2 ($\frac{3}{4}$ IN. \times .045 IN.) PEENED TO 0.008A2

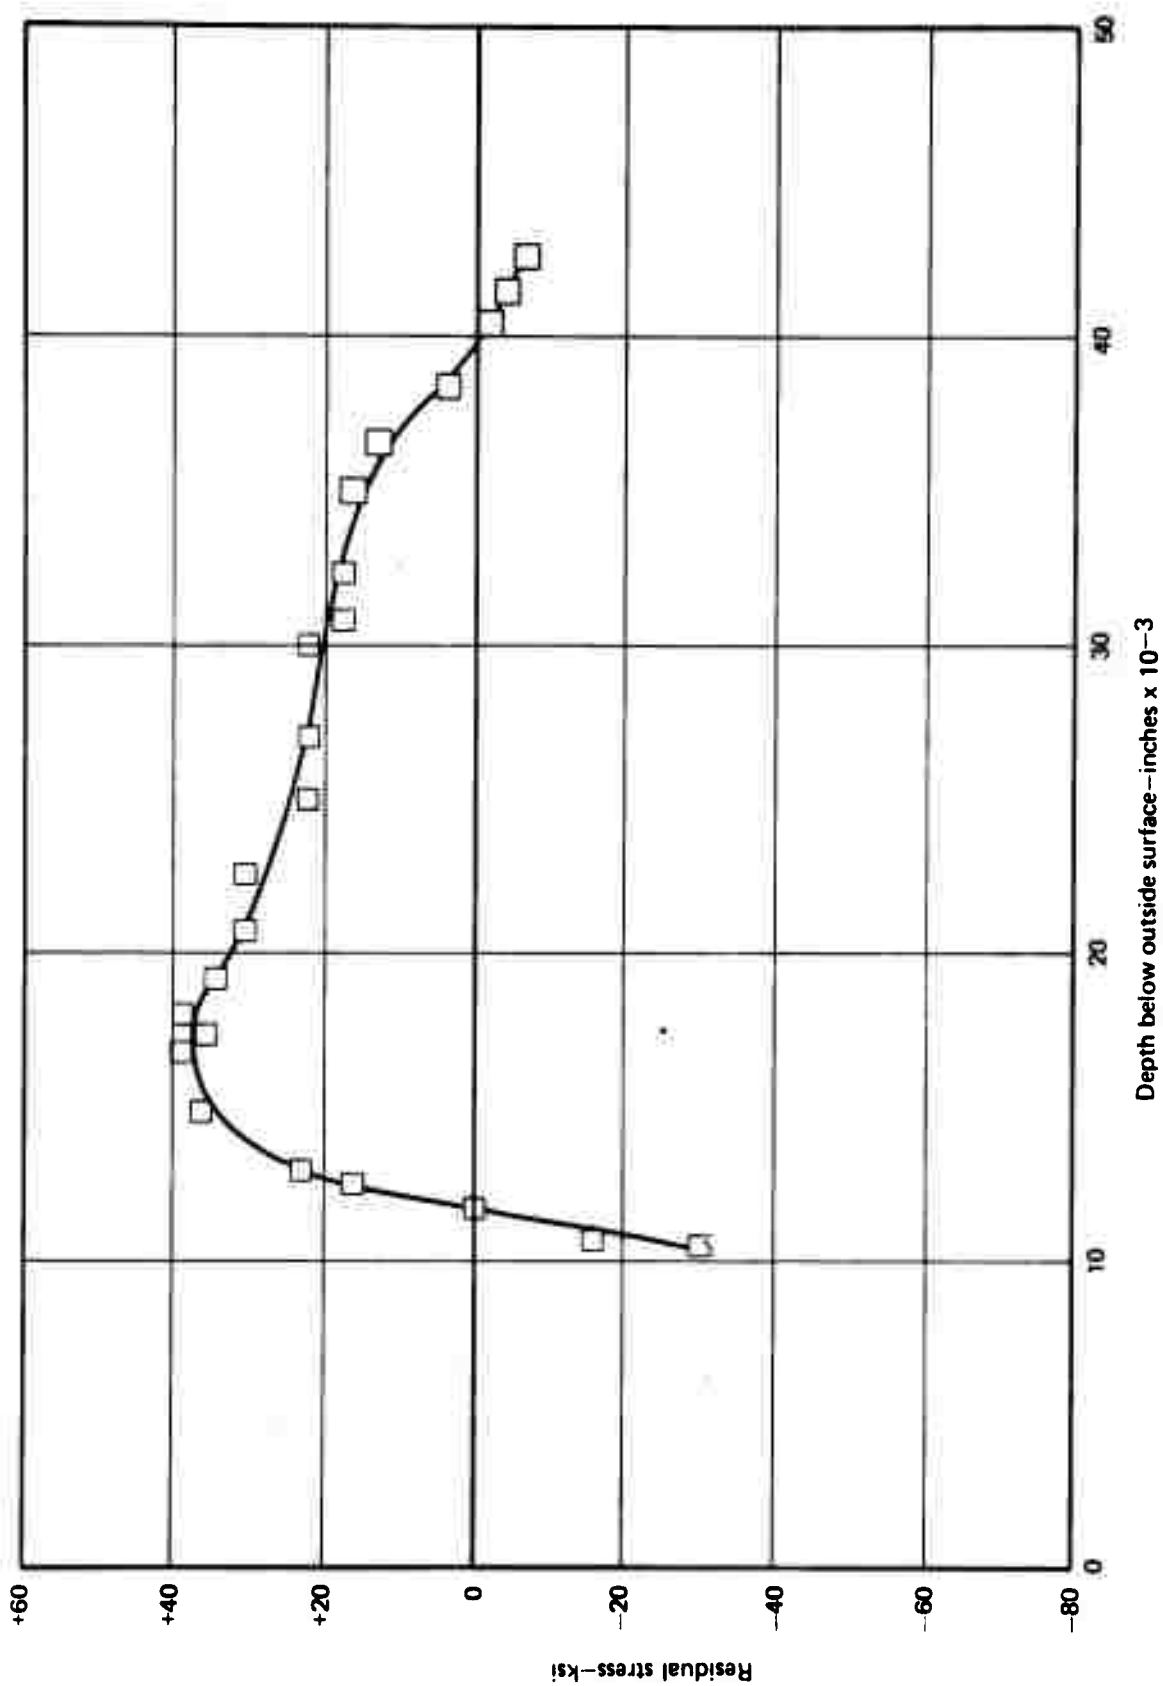
FIGURE 43. - RESIDUAL HOOP STRESS IN TUBE G-3 ($\frac{3}{4}$ IN. \times .045 IN.) PEENED TO 0.12A2

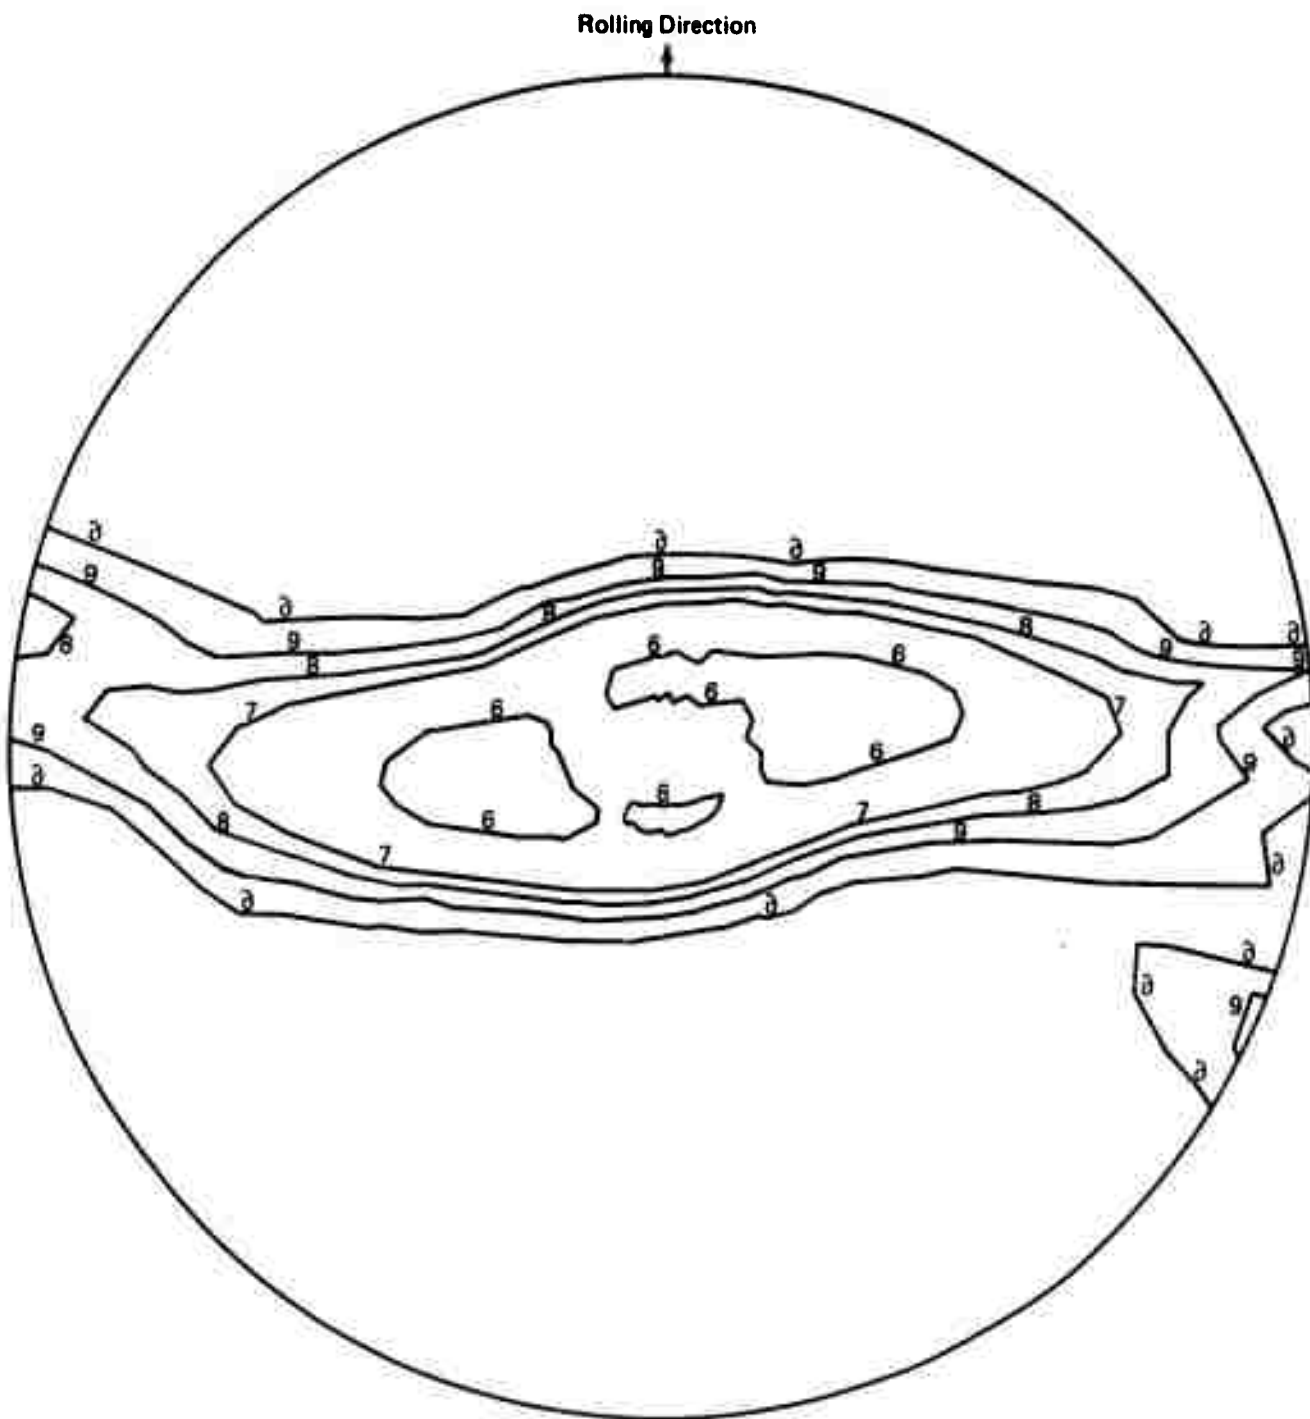
FIGURE 44.—POLE FIGURE SHOWING INTENSITY PROFILES OF BASAL PLANE REFLECTIONS FOR 1.0 IN. X 0.033 IN. RMI TUBING. DATA FOR THIS TUBING SHOWS THE STRONGEST RADIAL ORIENTATION IN COMPARISON WITH POLE FIGURES FOR THE OTHER TWO TUBING SAMPLES (FIGURES 45, 46)

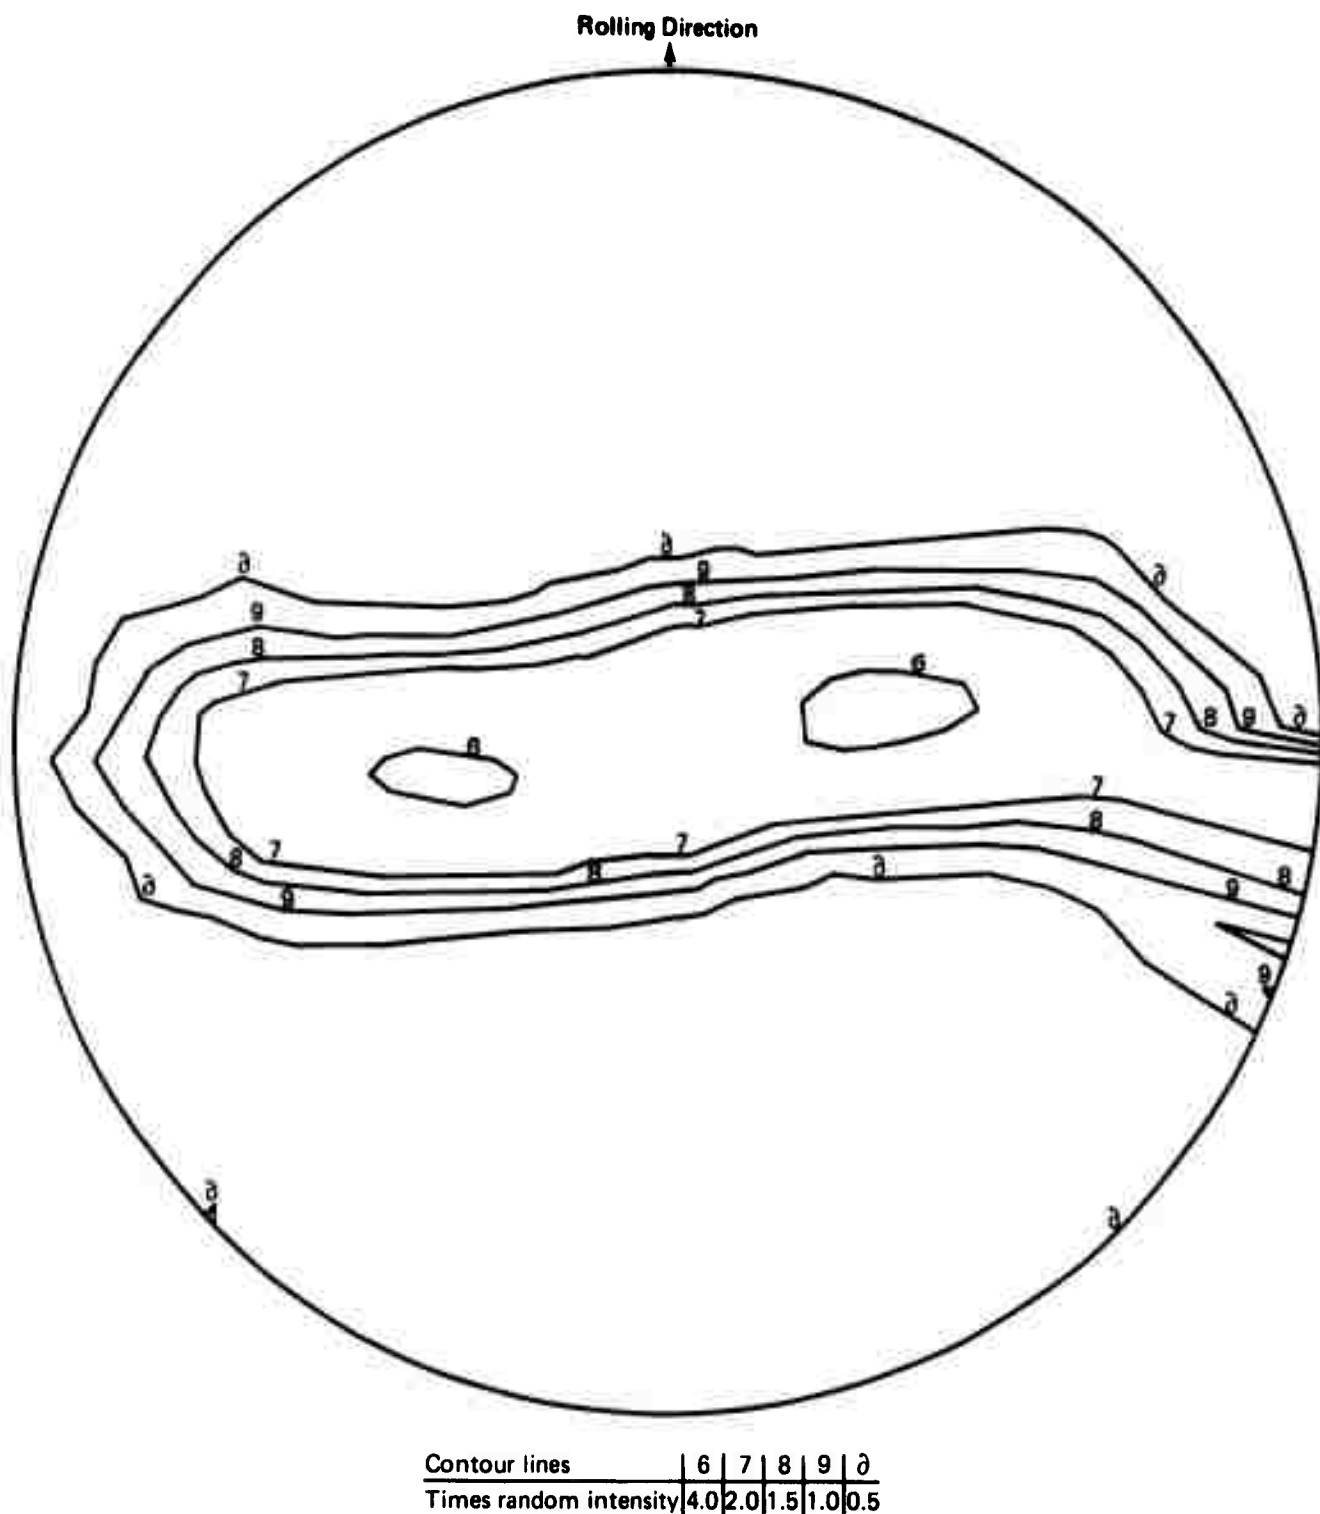
FIGURE 45.—POLE FIGURE SHOWING INTENSITY PROFILES OF BASAL PLANE REFLECTIONS FOR 1½ IN. X 0.120 IN. ZIRTECH TUBING. THE DATA SHOWS THE UNIT CELL AXES TO BE ORIENTED MORE STRONGLY IN THE RADIAL DIRECTION THAN FOR THE ½ IN. O.D. TUBING, (FIGURE 46) WITH PEAK INTENSITIES OCCURRING APPROXIMATELY 40° FROM A TRUE RADIAL DIRECTION

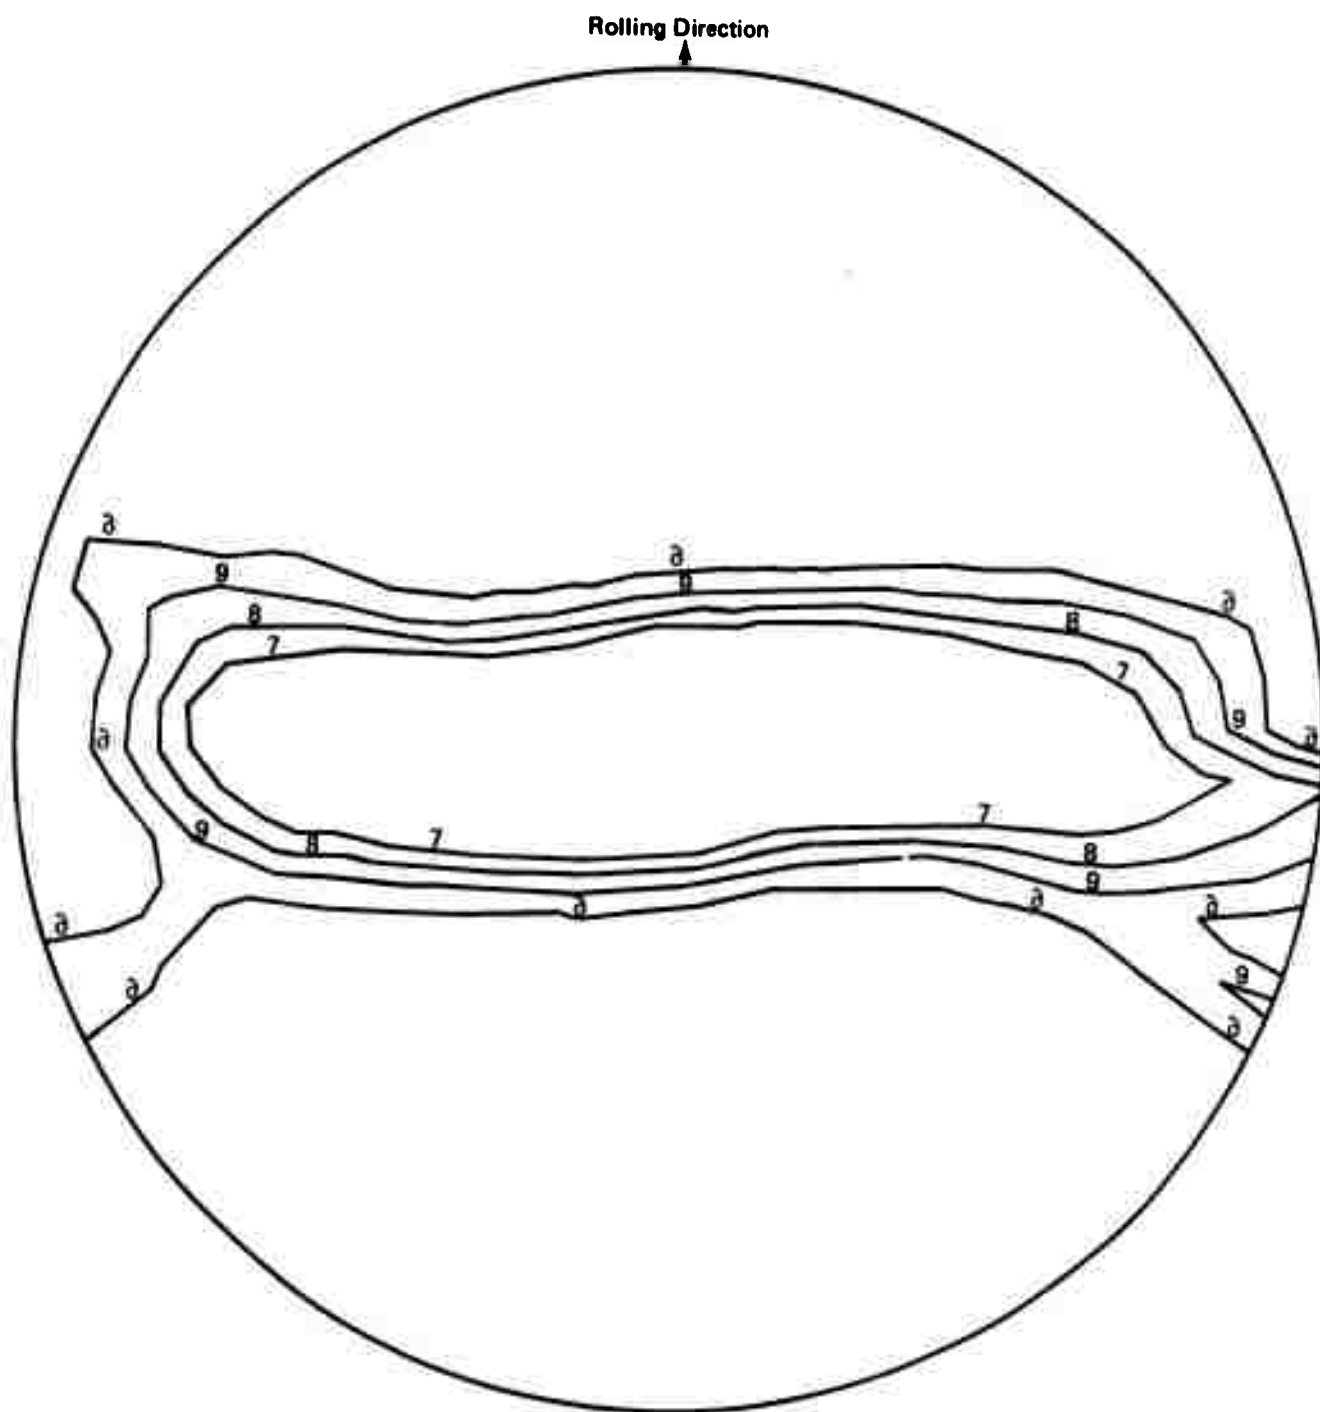
FIGURE 46.—POLE FIGURE SHOWING INTENSITY PROFILES OF BASAL PLANE REFLECTIONS FOR ½ IN. X 0.040 IN. ZIRTECH TUBING. THE DATA INDICATES THE AXES OF UNIT CELLS ARE DISTRIBUTED SOMEWHAT RANDOMLY BETWEEN A CIRCUMFERENTIAL AND A RADIAL ORIENTATION WITH A SLIGHT TENDENCY TOWARD A RADIAL ORIENTATION

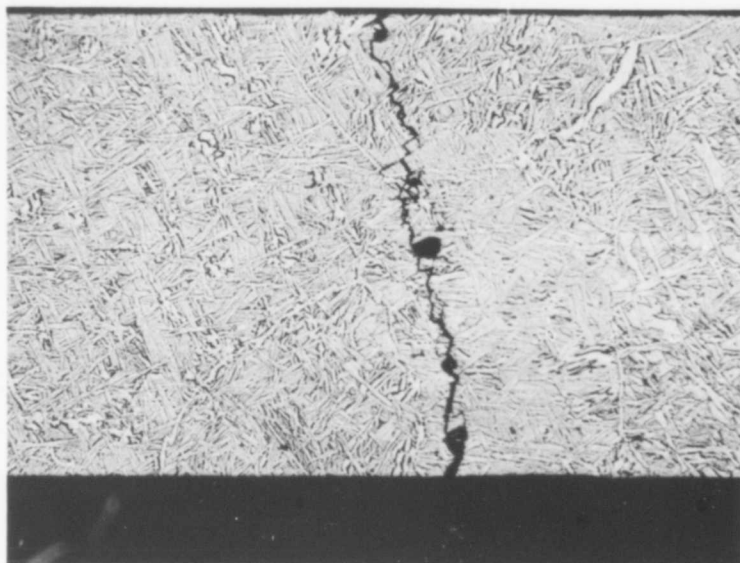
FIGURE 47. —PROFILE OF A CRACK WITH THE ORIGIN ON THE O.D.. THE CRACK IS VERY JAGGED AND TENDED TO FOLLOW PRIOR BETA GRAIN BOUNDARIES—NOTE THE CHANGE OF MICROSTRUCTURE AT RIGHT

In the referenced investigation, a $\frac{1}{2} \times 0.028$ in. tube was found to have a large grained Widmanstätten microstructure. This structure was produced in the tubing when it was heated above the beta transus during some phase in final processing. The material formed to the expected bend radius but due to the large grain size, the tube surface

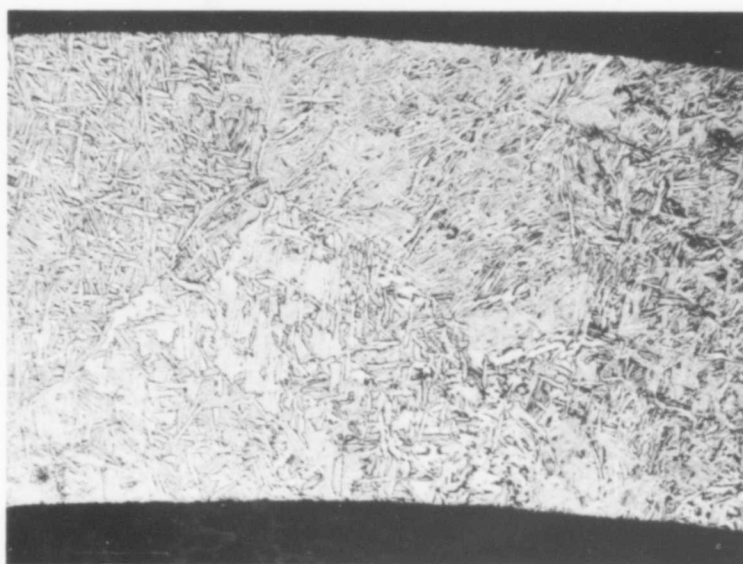
FIGURE 48. —COARSE WIDMANSTATTEN MICROSTRUCTURE—SECTION TAKEN FROM THE END OF THE TUBE AWAY FROM THE BRAZED JOINT
